TSD-12-015

Customer Complaints for Vibration -Tire/Rim Slip-

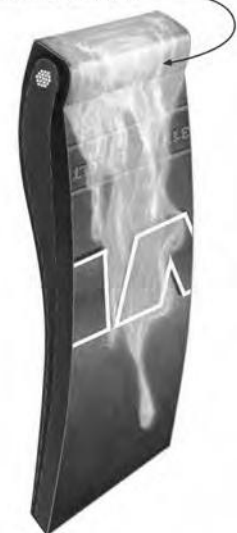
INCORRECT APPLICATION
OF LUBRICANT

The main cause of tire/wheel slip is excessive use of tire lubricant (shown on the right) on the tire beads and rim. Excessive lubricant reduces friction between the tire bead and the wheel, allowing the tire to slip within hours of mounting.

1. **For new tire and wheel assemblies, clean the tire beads of any manufacturing related lubricants with an approved rubber cleaner fluid commonly used in the tire repair process.**
2. **Clean the wheel bead seating area.**

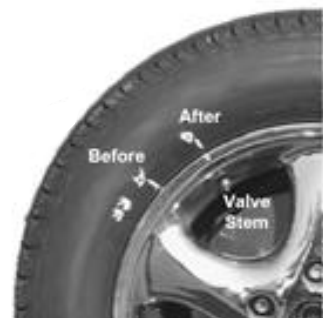
All of the test tires, regardless of brand or driving mode, slipped on the rim causing the assemblies to go out-of-balance. Toyo confirmed the results with several tire shops that monitored tire/rim slip by indexing the valve stem to the tire sidewall. One shop reported 3 inches of slip 12 hours after mounting and balancing resulting in a ride complaint.

3" slip after mild driving
(over)

4. **If more than 40 psi is required to seat the beads, dismantle the tire, re-lubricate and repeat the process. Always follow the advice of the tire and wheel manufacturer regarding maximum pressure.**
5. **Index the wheel valve stem to some location on the tire sidewall so that slippage can be confirmed in the event of a customer return for vibration.**
6. **In the event of a customer complaint where tire/wheel slip has occurred, remove the old weights and re-balance the assembly. Do not dismantle the tire unless there is a requirement to match-mount the assembly.**

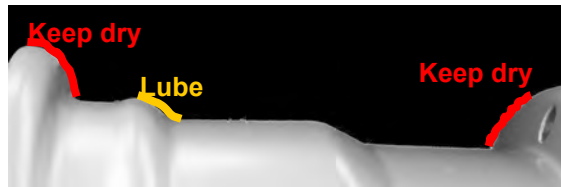
High performance, low profile passenger tires mounted on European-made alloy wheels may require higher mounting pressures, as bead seat tolerances may be tighter than domestic wheels. Additional lubrication of the safety hump (as shown below) may be required to facilitate bead seating.
