TSD-12-015

August, 2012

Customer Complaints for Vibration -Tire/Rim Slip-

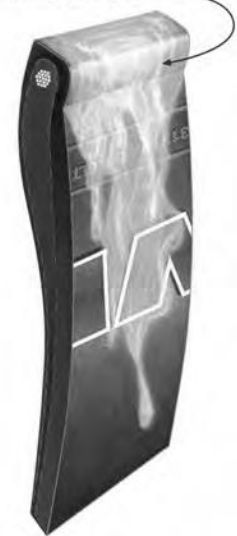
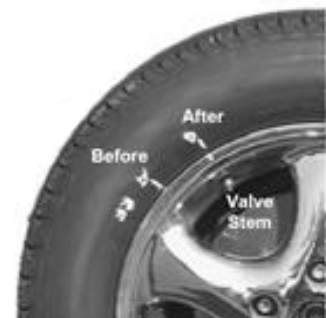
INCORRECT APPLICATION
OF LUBRICANT

The main cause of tire/wheel slip is excessive use of tire lubricant (shown on the right) on the tire beads and rim. Excessive lubricant reduces friction between the tire bead and the wheel, allowing the tire to slip within hours of mounting.

3" slip after mild driving
(over)

1. **For new tire and wheel assemblies, clean the tire beads of any manufacturing related lubricants with an approved rubber cleaner fluid commonly used in the tire repair process.**
2. **Clean the wheel bead seating area.**

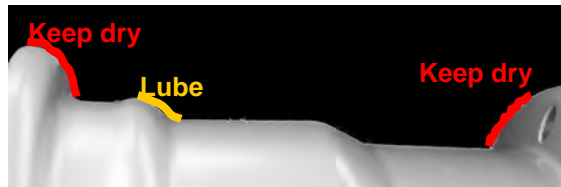
High performance, low profile passenger tires mounted on European-made alloy wheels may require higher mounting pressures, as bead seat tolerances may be tighter than domestic wheels. Additional lubrication of the safety hump (as shown below) may be required to facilitate bead seating.

4. **If more than 40 psi is required to seat the beads, dismount the tire, re-lubricate and repeat the process. Always follow the advice of the tire and wheel manufacturer regarding maximum pressure.**
5. **Index the wheel valve stem to some location on the tire sidewall so that slippage can be confirmed in the event of a customer return for vibration.**
6. **In the event of a customer complaint where tire/wheel slip has occurred, remove the old weights and re-balance the assembly. Do not dismount the tire unless there is a requirement to match-mount the assembly.**
